# tN4 Gateway 482

## Software Update

A new software version of the tN4 Gateway 482 has been released. The 482 has the ability to have its software updated in the field. Please follow this procedure to update the 482 software.

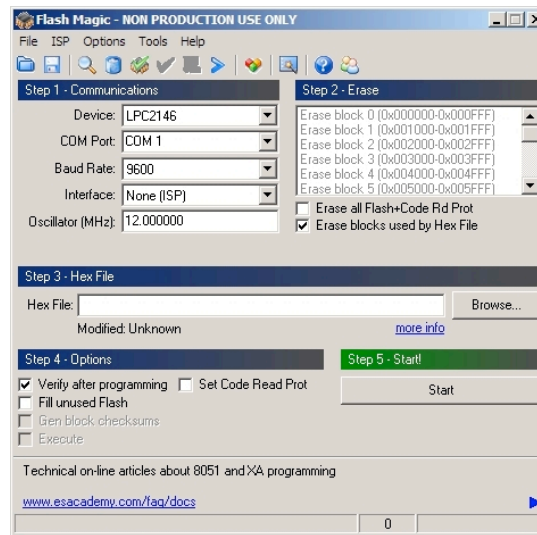
8. In the area labeled "Step 1" of the Flash Magic software change the "COM Port" to the port that the 482 is connected to. (If a USB-to-Serial converter is used, Start -> Settings -> Control Panel -> System -> Hardware -> Device Manager. Under "Ports", determine the COM Port used by the USB-to-Serial device.)

9. In the area labeled "Step 3" of the Flash Magic software click on the "Browse" button and locate the 482 software (101702\_J1196B.hex) on the desktop of the computer.
10. Click "Start" in the bottom right hand corner of the Flash Magic software. During programming, the Tx and Rx LED will flicker rapidly. Wait for Flash Magic to say that the programming is "Finished". Do not turn off the computer, the 482 or disconnect the 482 from the computer while the update is in progress.
11. Power off the 482 and disconnect it from the computer.
